不同裂纹参数下的转子系统振动特性试验

摘要: 以具有相同结构尺寸的四根多盘转子作为研究对象, 利用精密线切割的加工方式分别在四根转子的不同位置预制不同深度的横向裂纹。对裂纹参数发生改变的转子系统展开振动特性测试, 并分析裂纹转子的动力学响应特征与裂纹位置和裂纹深度之间的关系。试验结果表明: 1/2 临界转速区的 2× 共振现象以及 1/3 临界转速区的 3× 共振现象是转轴裂纹故障的典型特征, 其中 2× 共振峰值会在裂纹深度达到一个临界点后迅速增加; 而区别于已有研究结果, 3× 共振峰值会在裂纹深度达到临界点后突降; 同时, 引发 2× 和 3× 共振峰值发生突变的临界深度与裂纹位置是否处于轮盘根部存在关联。

Vibration characteristic experiments of rotor system with different crack parameters

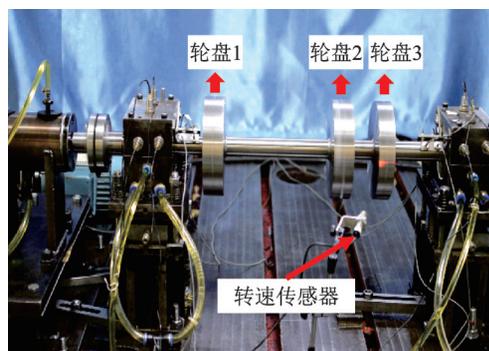
试验过程中所使用的多盘转子系统动力学特性测试试验台如图1所示。制造转子所用金属材料为

图1 多盘转子系统动力学特性测试试验台

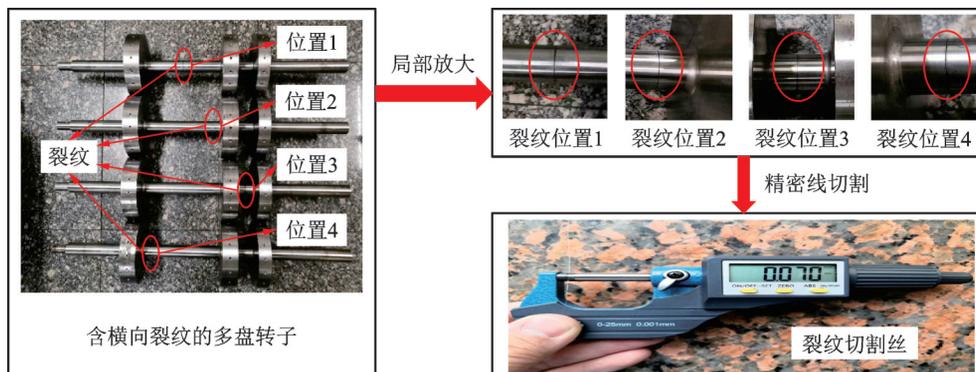
如图2所示,本次试验共制造了四根相同规格尺寸的多盘转子。采用精密线切割的加工方式分别在四根转子的不同位置加工不同深度的横向裂纹,裂纹宽度为0.07 mm,裂纹具体位置以及与试验台相关的更多细节被展示在图3中。

图2 裂纹转子示意图

完成试验台的搭建工作后,接通润滑油供油管路。380 V 交流电机驱动转子均匀升速,整个升速阶段持续 5 min,转子的最高转速为 4000 r/min,采集转子整个升速阶段 1#轴承座附近的振动位移信号。参考图 2 和 3,虽然四根转子的结构尺寸是相同的,但所有转子的初始振动状态仍然无法保持一致。因为实际运行环境中存在大量的不确定干扰,同时制造转子的过程中也将产生一定的加工误差。为解决这一问题,所有的转子在被植入裂纹故障前都进行了动平衡,由此使得四根转子的初始振动大致保持在同一数量级。此外,在对每一根裂纹转子的振动特性展开测试的过程中,保持裂纹位置不变且裂纹深度逐渐增加。不同裂纹参数下转子的振动测试数据采集分析流程如图 4 所示。

图 8 进一步给出不同转子在 1/2 临界转速区 2×共振峰值随裂纹相对深度的变化情况。当裂纹深度较浅时,2×共振峰值在较小的范围内随机波动,裂纹深度的增加几乎很难对其造成影响。在裂纹深度达到某一个临界点后,2×共振峰值将进入快速增长阶段。然而,该临界深度对于裂纹位置不同的四根转子而言有所区别。如图 8 所示,裂纹位置 1 的临界点为裂纹深度超过转轴直径的 20%,裂纹位置 2、3、4 的临界点为裂纹深度超过转轴直径的 30%。参考图 2 和 3,裂纹位置 2、3、4 处于轮盘根部,裂纹位置 1 则处在距离轮盘较远的轴段处。由于轮盘所在部位质量较为集中,相比于轴段部分轮盘根部不易变形,故裂纹处在位置 1 时转子的 2×故障特征对裂纹深度的持续增加更敏感,即图 8 中黑色曲线更早进入快速增长阶段。

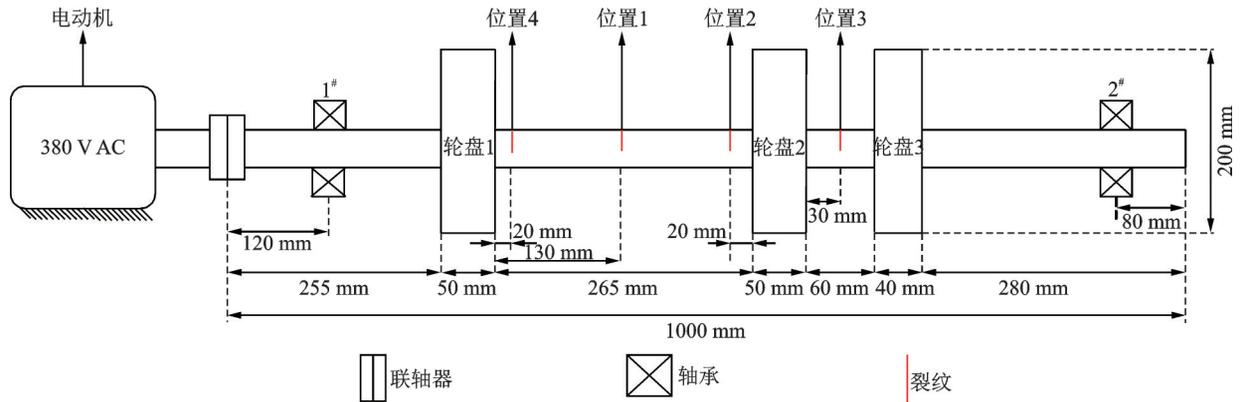
图3 试验台相关细节

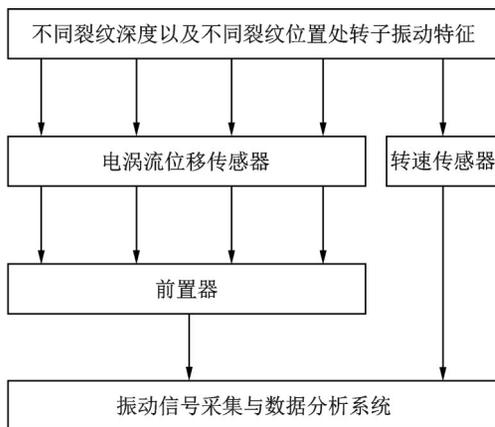
图4 试验数据采集分析流程

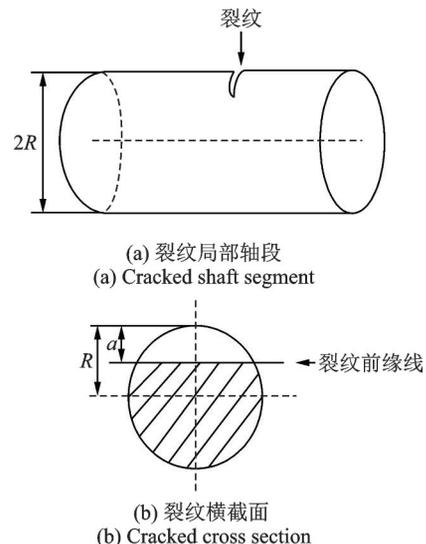
裂纹局部截面如图 5 所示,定义无量纲裂纹相

对深度 \bar{a} ($\bar{a} = a/(2R)$),其中 a 为实际裂纹切割深度, $2R$ 为轴径,轴径取值如表 1 所示。图 6 给出了四根转子裂纹深度逐渐增加时, $1\times$ 振动幅值随转速的变化情况。显然, $1\times$ 响应在临界转速处出现峰值。依据经典有限元理论^[31-33],若裂纹深度不断增加,则裂纹转子在临界转速处的 $1\times$ 共振峰值随之增加且临界转速略有提前。然而从图 6 中可以看出,临界转速大致分布在 2900~3300 r/min 且随裂纹深度的变化具有一定的随机性。虽然图 6(a) 和 (b) 表明,裂纹产生后临界转速处的 $1\times$ 响应峰值随裂纹深度的增加而单调递增,但图 6(c) 和 (d) 中却呈现出不一样的结果。由此可见,转子在实际运行过程中将面临油膜力、背景环境噪声、制造加工误差、材料物性分布不均以及其他无法确定的外部激励等多重因素的干扰,进而导致裂纹转子的临界转速和相应的 $1\times$ 共振峰值随裂纹参数的变化趋势与理论计算结果存在差别。基于此,无法将临界转速和相应的 $1\times$ 共振峰值作为转轴裂纹故障精确识别的指标。

图5 裂纹局部示意图

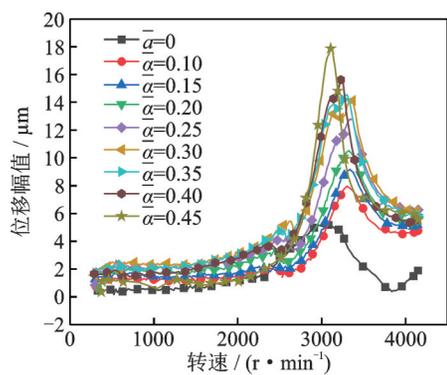
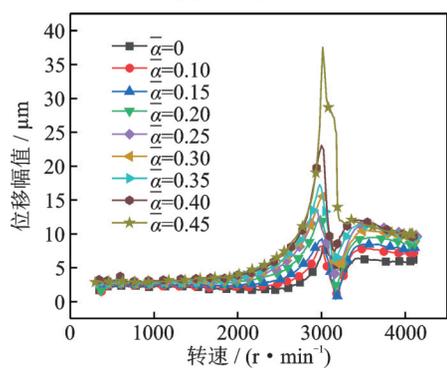
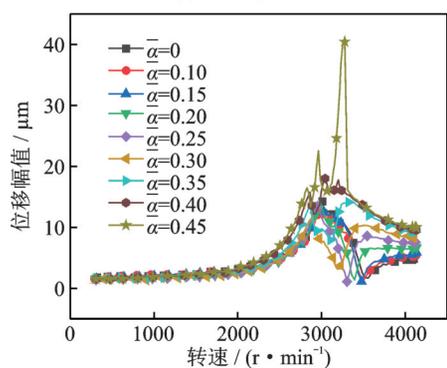
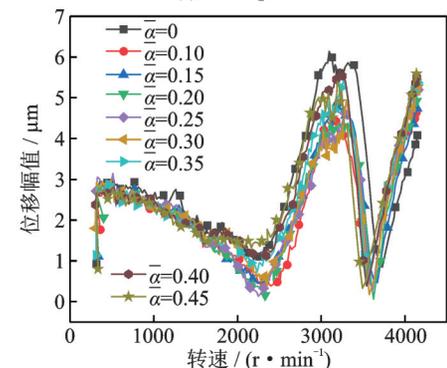
(a) 裂纹位置1
(a) Crack position 1

(b) 裂纹位置2
(b) Crack position 2

(c) 裂纹位置3
(c) Crack position 3

(d) 裂纹位置4
(d) Crack position 4

图6 1×振动幅值随转速变化规律

(1) 转子的临界转速以及临界转速处的 $1\times$ 共振幅值随裂纹参数的变化过程呈现出一定的随机性,无法将其作为转轴裂纹故障精确定位、定量识别的参照指标。

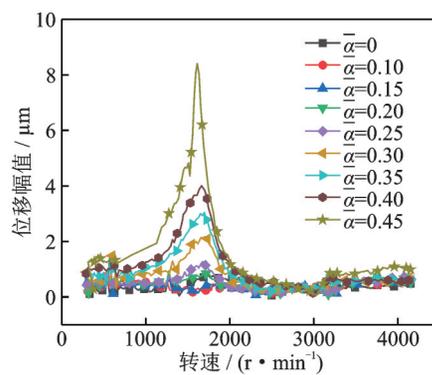
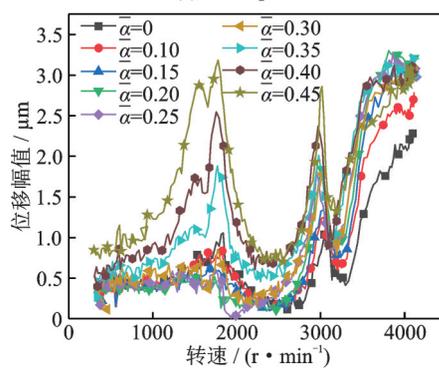
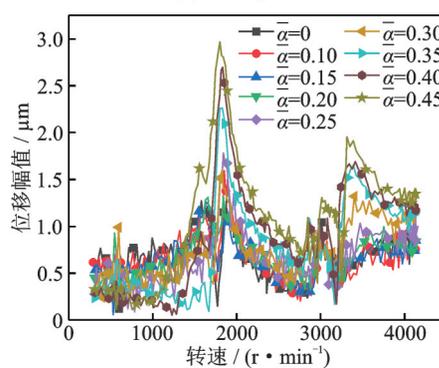
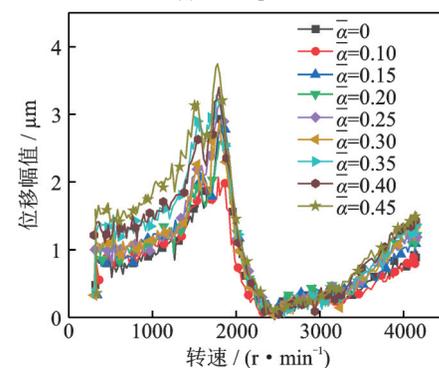
图7展示了不同裂纹位置、不同裂纹深度工况下,裂纹转子的2×振动幅值随转速的变化规律。作为转轴裂纹故障的动力学特征之一,1/2临界转速区

(a) 裂纹位置1
(a) Crack position 1

(b) 裂纹位置2
(b) Crack position 2

(c) 裂纹位置3
(c) Crack position 3

(d) 裂纹位置4
(d) Crack position 4

图7 2×振动幅值随转速变化规律

存在2×共振现象。尽管无裂纹状态下转子本身含有2×超谐波频率成分,但随着裂纹深度的增加,1/2临界转速区的2×振动幅值仍出现显著变化^[34]。

综合图 7 和 8 可知,如果对转子的振动行为进行在线监测的过程中发现转子在 1/2 临界转速区附近存在明显的 2×共振现象,表明转轴含有裂纹故障且裂纹深度至少超过转轴直径的 20%。同时,若 2×共振峰值持续大幅度增长,则裂纹故障正在逐渐恶化且裂纹大致位于远离轮盘根部的轴段处。相反,若 2×共振峰值处于持续小幅度增长,则裂纹大致位于轮盘根部,此时裂纹故障已至少恶化到转轴直径的 30%。所以,通过分析表明转子在 1/2 临界转速区的 2×共振现象不仅可用于识别转轴裂纹故障,其 2×共振峰值还可作为裂纹故障定位、定量精确识别的指标。

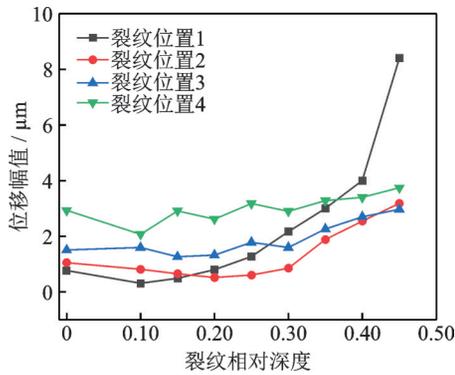
图 8 2×峰值随裂纹深度变化情况

(2) 如果存在轴裂纹故障,则转子在经过 $1/2$ 临界转速区时出现 $2\times$ 共振现象。在裂纹故障早期 $2\times$ 共振幅值随裂纹深度的变化表现出随机性,若裂纹深度达到临界点后 $2\times$ 共振幅值将进入快速增长期。当裂纹位置处在轮盘根部时,该临界深度为转轴直径的 30%。当裂纹位置处在远离轮盘根部的轴段时,该临界深度为转轴直径的 20%。据此, $1/2$ 临界转速区的 $2\times$ 共振幅值可作为转轴裂纹故障精确定位、定量识别的参考指标。

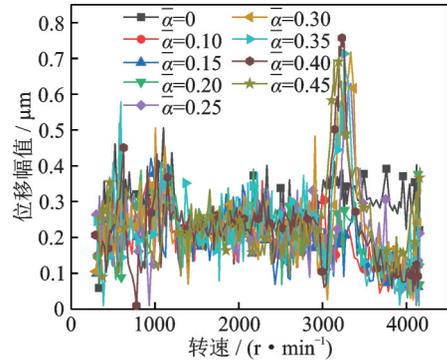
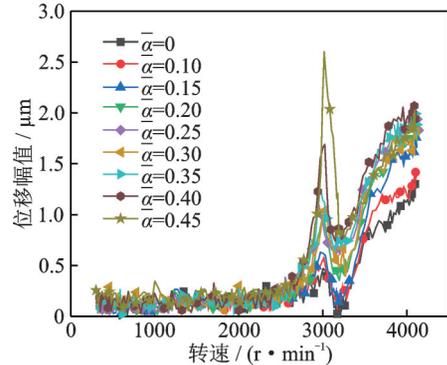
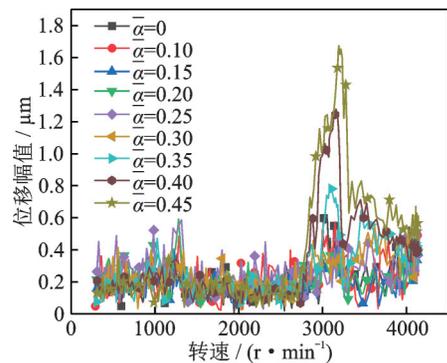
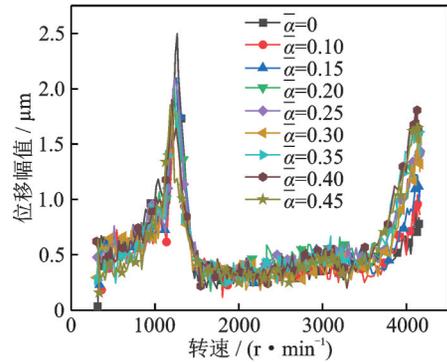
图 9 给出了不同裂纹深度下,四根裂纹转子的 3×振动幅值随转速变化的情况。通常,转子发生轴裂纹故障将引发 1/3 临界转速区的 3×共振现象^[34-36]。虽然无裂纹时转子存在 3×超谐波频率成分,但裂纹深度的增加对 1/3 临界转速区的 3×振动幅值仍然产生了一定的影响。然而 3×成分本身是一个弱信号,极易被杂波所干扰。如图 9(a)~(c)所示,裂纹转子在 1/3 临界转速区的 3×共振特征不明

显,甚至该转速区附近其他转速处的 3×振幅都要大于此 3×共振峰值。不同于图 9(a)~(c)所代表的三根转子,图 9(d)表明若裂纹处于位置 4,则转子在 1/3 临界转速区存在明显的 3×共振特征。

(a) 裂纹位置 1
(a) Crack position 1

(b) 裂纹位置 2
(b) Crack position 2

(c) 裂纹位置 3
(c) Crack position 3

(d) 裂纹位置 4
(d) Crack position 4

图 9 3×振动幅值随转速变化规律

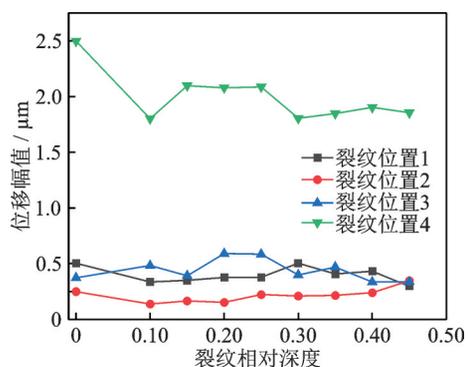
四根转子在 $1/3$ 临界转速区的 $3\times$ 共振峰值随裂纹深度变化的差别被进一步反映在图 10 中,从中可以看出所有转子的 $3\times$ 共振峰值并未随裂纹深度的增加而单调递增,转子结构形式的不同以及外部干扰的综合作用使得当前研究结果与以往有所区别^[21,33-34,37-38]。 $3\times$ 振动信号在裂纹故障早期不稳定,在裂纹深度达到一个临界点后,所有转子在 $1/3$ 临界转速区的 $3\times$ 共振幅值发生突降。对于裂纹位置 2、3、4 而言,这一临界点为裂纹深度超过转轴直径的 25%。区别于这三根转子,当裂纹处在位置 1 时,这一临界点为裂纹深度超过转轴直径的 30%。如前所述,裂纹位置 2、3、4 位于轮盘根部,裂纹位置 1 位于远离轮盘的轴段处。显然,产生这一现象的原因类似于 $2\times$,即四根转子在 $1/2$ 临界转速区的 $2\times$ 共振峰值进入快速增长阶段的临界深度不同。

图 10 $3\times$ 峰值随裂纹深度变化情况

由此可见,裂纹转子在亚临界转速区的 $3\times$ 超谐波响应峰值也可作为转轴裂纹故障定位、定量识别的参考指标。但在裂纹故障早期, $3\times$ 信号不稳定,故利用 $1/3$ 临界转速区的 $3\times$ 共振幅值较难识别微小裂纹。如果在对裂纹转子振动行为在线监测的过程中发现, $1/3$ 临界转速区的 $3\times$ 共振现象逐渐明显且 $3\times$ 共振幅值发生突降,则裂纹深度至少超过转轴直径的 25%。此外图 10 中还表明,若达到突降点前 $3\times$ 共振幅值持续增加,则裂纹位于远离轮盘的轴段处,反之裂纹部位在轮盘根部。然而 $1/3$ 临界转速区的 $3\times$ 超谐波响应成分是一个弱信号,故在裂纹故障诊断的过程中需综合 $1/2$ 临界转速区的 $2\times$ 响应做出判断,以此提高诊断的精确度。

(3) 轴裂纹故障将导致转子在经过 $1/3$ 临界转速区时出现 $3\times$ 共振现象, $3\times$ 信号较弱且在故障早期不稳定。随着裂纹深度逐渐增加至临界点, $3\times$ 共振现象趋于明显。而区别于已有研究结果, $3\times$ 共振幅值在裂纹深度达到临界点后发生突降。当裂纹位置处在轮盘根部时,该临界深度为转轴直径的 25%。当裂纹位置处在远离轮盘根部的轴段时,该临界深度为转轴直径的 30%。基于此, $3\times$ 共振幅值可作为转轴裂纹故障精确定位、定量识别的参考指标。但 $3\times$ 振动信号属于弱信号,在判定故障时需结合 $1/2$ 临界转速区的 $2\times$ 共振现象以提高精确度。
